#18-NA-161: Steering Jerks Or Kicks Back / Reduced Power Steering Assist / Engine Stall / No Start / Service Stabilitrak / IPC / Radio / HVAC Goes Blank Various DTCs - (May 17, 2018)

Subject: Steering Jerks Or Kicks Back / Reduced Power Steering Assist / Engine Stall / No Start / Service Stabilitrak / IPC / Radio / HVAC Goes Blank Various DTCs

This bulletin replaces PIT5405C. Please discard PIT5405C.

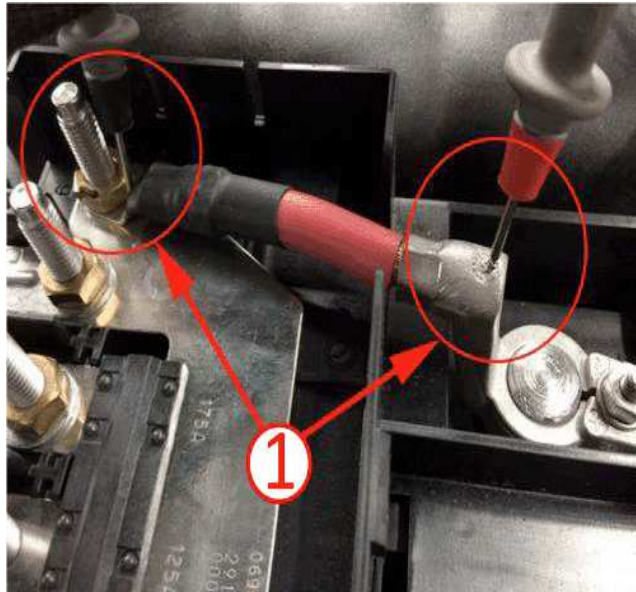
Cause 1	<p>This condition may be caused by battery cables with high resistance and/or loose connections at the:</p> <ul style="list-style-type: none"> • Positive or negative battery cables • Battery fuse block
Cause 2	<p>This condition may be caused by a poor BCM ground at G218.</p>
Cause 3	<p>This condition may be caused by a shorted B+ Battery cable (3) at the Starter Solenoid caused by:</p> <ul style="list-style-type: none"> • A loose starter shield contacting the starter battery cable terminal ring. • A starter cable ring terminal that has been mis-installed and/or rotated when installed on the starter solenoid.
Cause 4	<p>This condition may be caused by a discharged or faulty battery.</p>
Correction 1	<p>Important: The following steps must be completed in order. Grasping or attempting to rotate cables could affect readings and should be done after performing the voltage drop measurement.</p> <p>Note: When checking voltage drop, the voltage drop should be performed with the fuel system disabled (or hold the accelerator WOT) and while cranking the engine. MIN/MAX on the Digital Multi Meter (DMM) should NOT be used. The voltage drop should be monitored at a STEADY crank.</p> <p>Inspect for any high resistance and/or loose connections at both the battery fuse block and the positive or negative battery cables.</p> <p><small>© 2018 General Motors. All rights reserved.</small></p>

1. Perform a loaded voltage drop test on the short positive battery cable (1).

⇒ Refer to "Measuring Voltage Drop" in SI. If the voltage drop is above 200 mV, replace the affected cable(s).

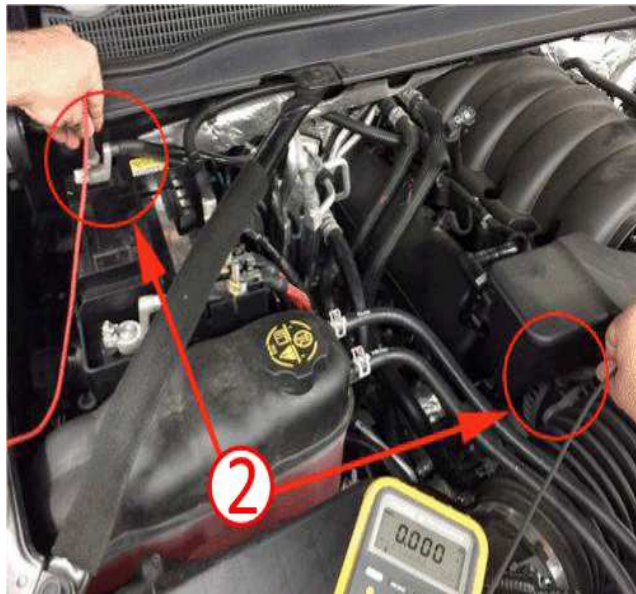
2. Perform a loaded voltage drop test on the negative battery cable (2).

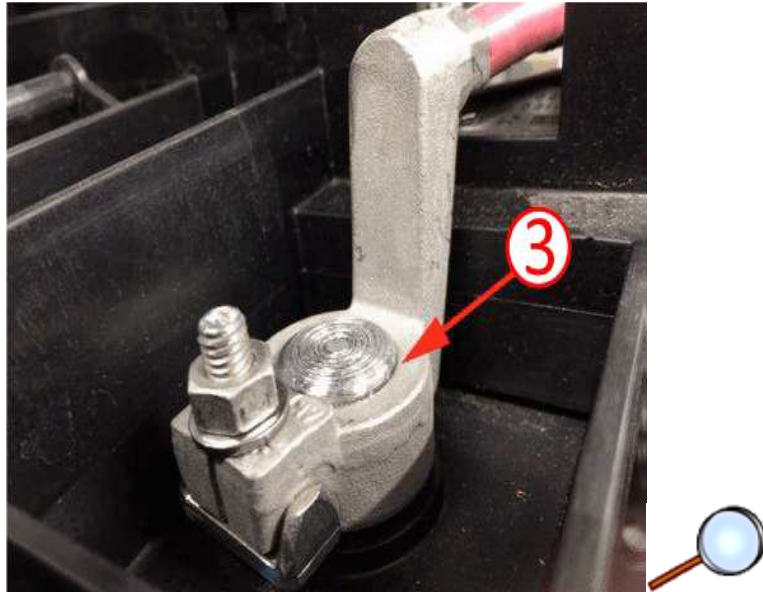
⇒ It is imperative that both the positive and negative battery top posts protrude above the battery cable clamps 1-2 mm (0.040 - 0.080 in) to be properly installed, as shown (3).

3. Check both the positive and negative battery cable clamp nuts and make sure they are properly tightened to 7 Nm (62 lb in).
4. After the positive and negative battery cables are fully installed and tightened to 7 Nm (62 lb in), grasp each battery cable near the battery post and make sure they are secure and that they do not spin on the post. If so, replace the battery cable.

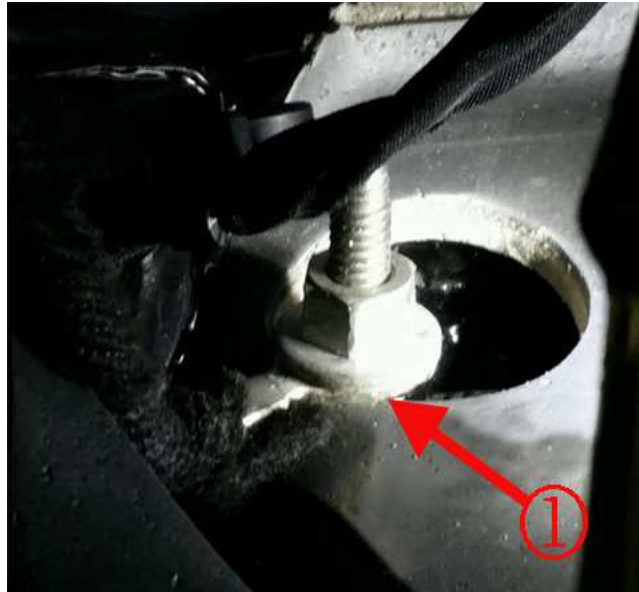
- Check for the nut being loose or cross threaded (1), repair and tighten as necessary.

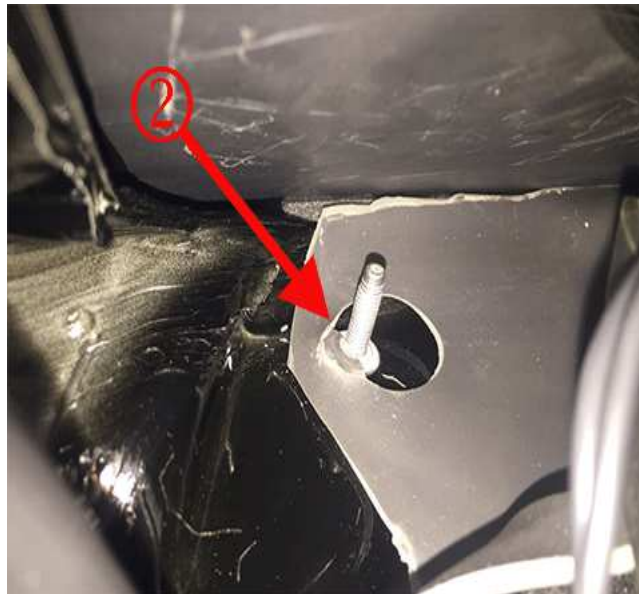
- Check for the front of dash insulator mat (2) being trapped between the ground eyelet and the body/stud as shown.
⇒ If the dash insulator mat is trapped, cut the mat away from the ground stud so it will no longer interfere. Reinstall the ground eyelet, the nut, and retighten.

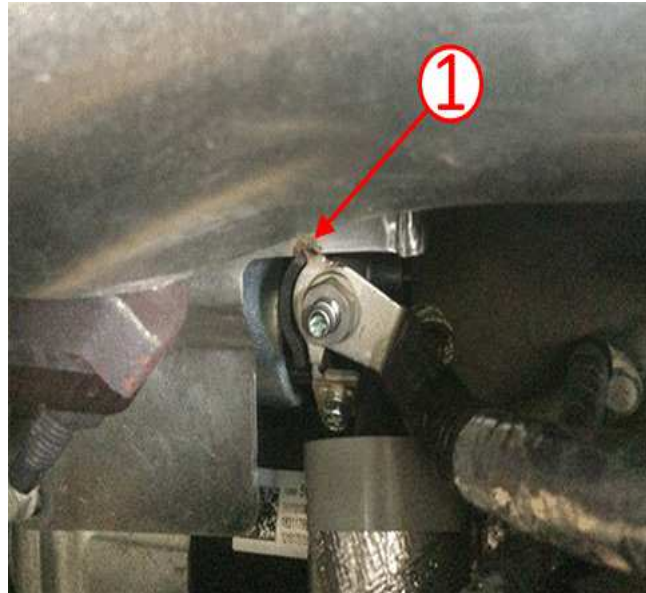
Inspect the starter solenoid B+ battery cable for possible contact at the starter heat shield (1) or a loose shield resting on terminal.

⇒ If the battery cable is shorting out on the starter heat shield, replace the B+ battery cable and starter heat shield.

⇒ After installing the new starter heat shield and B+ battery cable, ensure there is adequate clearance and each fastener is torqued properly so it will no longer short out.
