## #PIT5452B: Upper Steering Column Or Steering Wheel Pop Click Tick Snap Itch Noise While Turning The Steering Wheel - (Aug 21, 2017)

**Subject: Upper Steering Column Or Steering Wheel Pop Click Tick Snap Itch Noise While Turning The Steering Wheel**

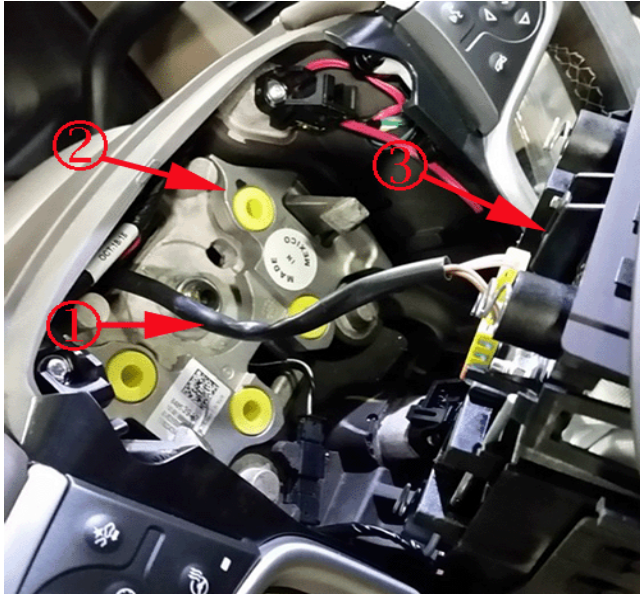
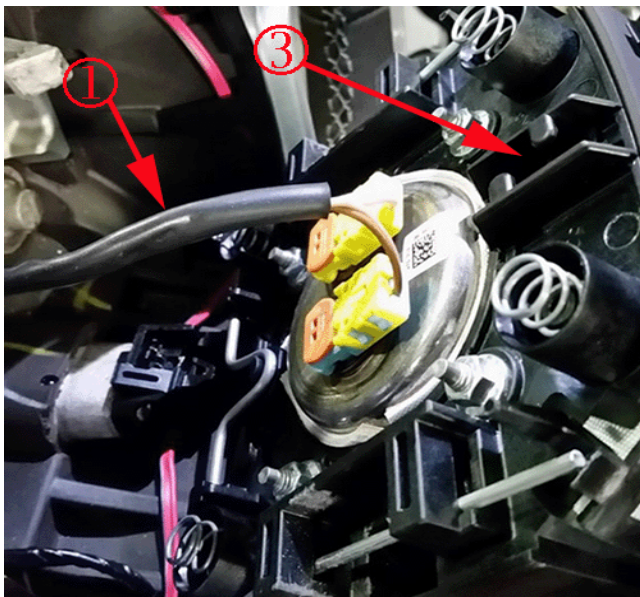
Cause-1: This noise may be caused by mis-routed airbag module wiring coming in contact with the vibration damper plate in the steering wheel, causing the plate to contact the side of the steering wheel while turning.

It has been found that if the steering wheel to airbag wiring harness (1) is Not routed within the wiring channel (3) molded into the back of the airbag module, the harness could contact the damper plate (2) within the steering wheel, and cause the damper plate to contact the side of the steering wheel during turns.

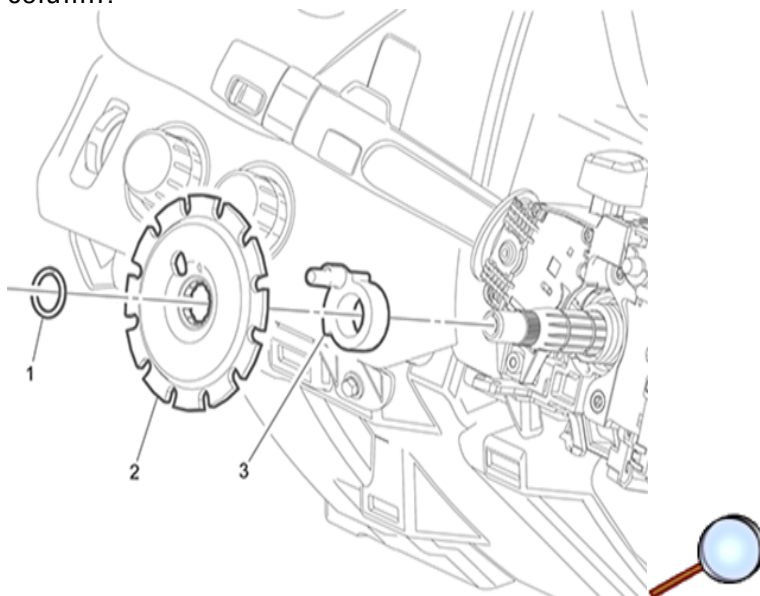
Cause-2 (RPO N38 Only): This noise could be caused by the upper column bearing race being slightly out of alignment.

1.1 Remove the steering wheel from the column.

1.2 Remove the steering column lock plate ring (1), lock plate (2) and cancel cam (3) from the column.
