# Service Bulletin

Bulletin No.: 22-NA-015

**Subject:** Diagnostic Tip on Shake and/or Shudder During Light Throttle Acceleration Between 25 and 80 MPH (40 and 128 KM/H) at Steady Speed

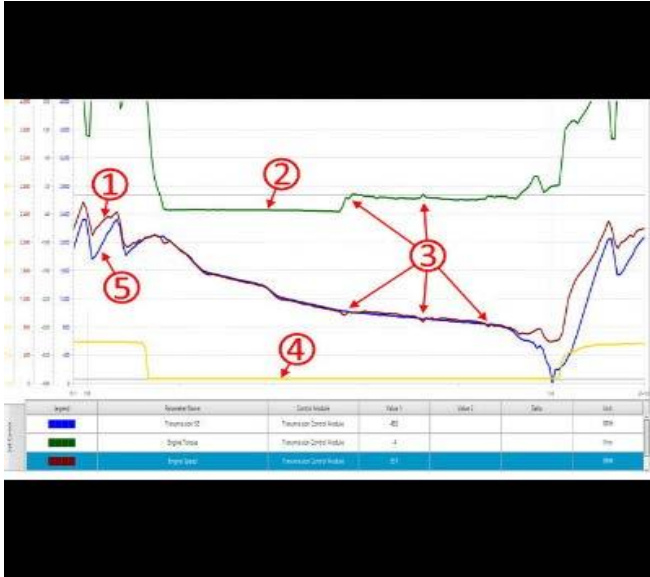
5975000

Diagnostic Tip Closed Throttle Shudder – TSB 21-NA-207: 2021 Silverado Sierra 5.3 (L84) 10 Speed (MQB) only.

The condition is only present at 0% throttle during a coast event at approximately 15 mph (24 km/h). Note the engine RPM and torque oscillations at engine refuel points.

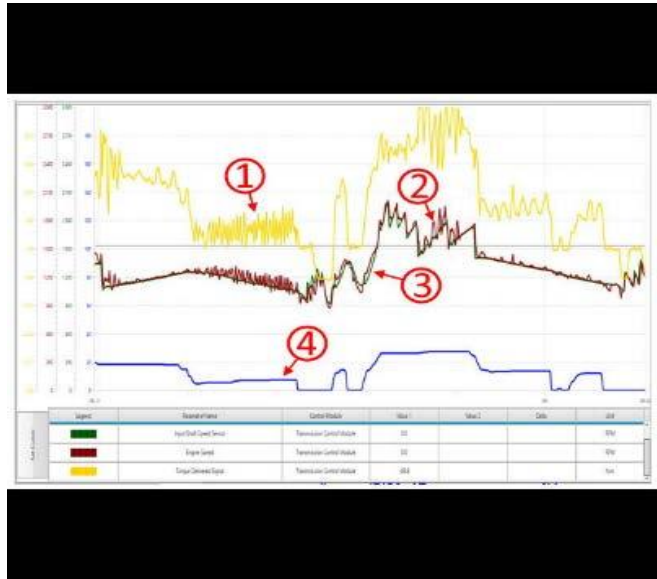
5975002

Record a GDS session log and monitor engine speed, transmission input speed and engine torque. If engine torque is larger than  $\pm 25$  Nm while no gear shift is active, and throttle is relatively constant the issue most likely lies within the engine.

Observe the large variation in engine torque while engine speed and turbine speed follow each other more closely. Although this feels like shudder to the customer it is most likely an engine related concern.

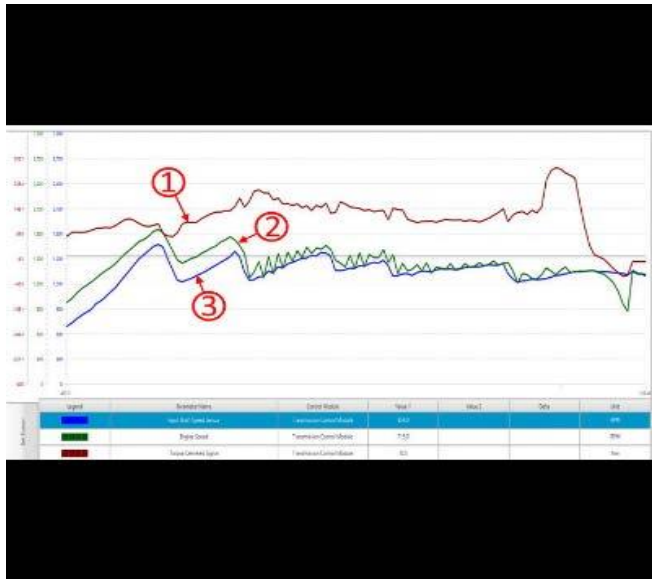
5975003

1. Torque
2. Engine Speed
3. Turbine Speed
  - The shudder condition is present both in Drive “D” or Manual “L9”.
  - Typically occurs at less than 15,000 miles (24,000 km)
  - Turbine speed follows engine speed
  - Relatively consistent engine torque.  $\pm 25$  Nm

Engine torque remains relatively flat while engine speed rises and falls. The valve body should be replaced.

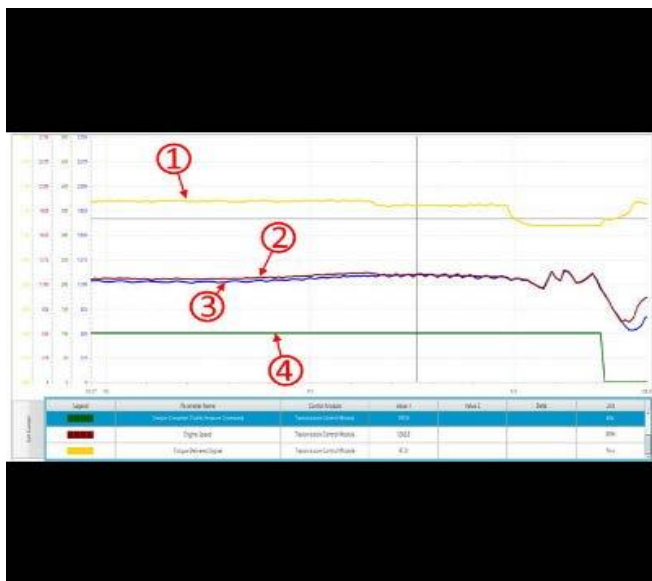
5975005

3. Turbine Speed
4. TCC Pressure
  - Shudder condition is present in Drive “D” but NOT present in Manual “L9”
  - Throttle would typically be less than 10% and engine torque less than 100 Nm
  - TCC slip speed will be 0 or near 0
  - TCC pressure command will remain at 100 kPa

The valve body should be replaced.

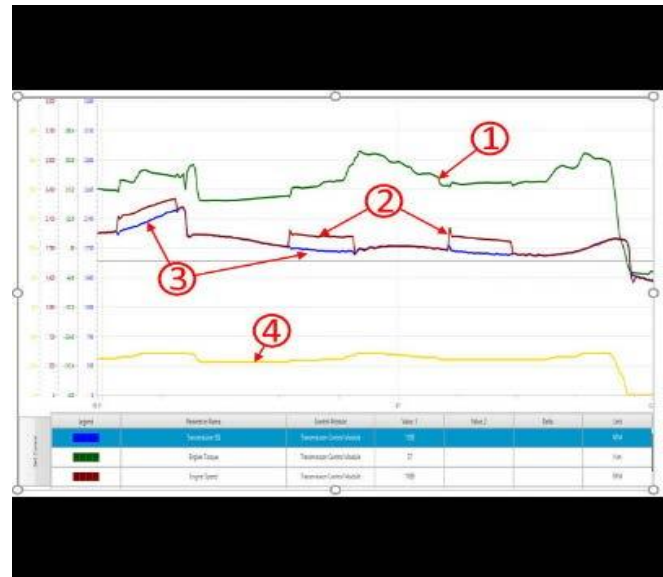
5975007

1. Torque
2. Engine Speed
3. Turbine Speed
4. Pedal
  - TCC pressure control is steady
  - TCC slip is elevated
  - Engine RPM will increase at the shudder point while turbine speed remains steady
  - Engine torque remains relatively steady during the shudder event
  - Throttle angle remains steady during the shudder event

The torque converter should be replaced.
