## **#08-07-30-021E: Loss of High Speed GMLAN Communications, Intermittent No Crank, IP Gage Fluctuation, Intermittent Door Lock Cycling, Intermittent Chime Operation, Various IP Warning Lamps Illuminated - (Jun 7, 2010)**

**Loss of High Speed GMLAN Communications, Intermittent No Crank, IP Gage Fluctuation, Intermittent Door Lock Cycling, Intermittent Chime Operation, Various IP Warning Lamps Illuminated, Transmission May Not Shift, Communication DTCs U0073, U0100, U0101, U0102, U0109, U0121 or U0140 Set (Repair Backed Out Terminal in Transmission Harness Connector, Repair Open or Shorted GM High Speed LAN Circuits, Open or Shorted Data Link Resistor, Correct Corrosion or Poor Connections in Various Control Module Connectors)**

**2007-2010 Cadillac Escalade Models, XLR  
2009-2010 Cadillac Escalade Hybrid  
2007-2010 Chevrolet Avalanche, Corvette, Silverado, Suburban, Tahoe  
2008-2010 Chevrolet Silverado Hybrid, Tahoe Hybrid  
2007-2010 GMC Sierra, Yukon Models  
2008-2010 GMC Sierra Hybrid, Yukon Hybrid  
2008-2009 HUMMER H2  
Equipped With 6 Speed 6L80 (RPO MYC) or 6L90 (RPO MYD) or Hybrid Two Mode 2ML70 Automatic Transmission  
Please Refer to GMVIS**

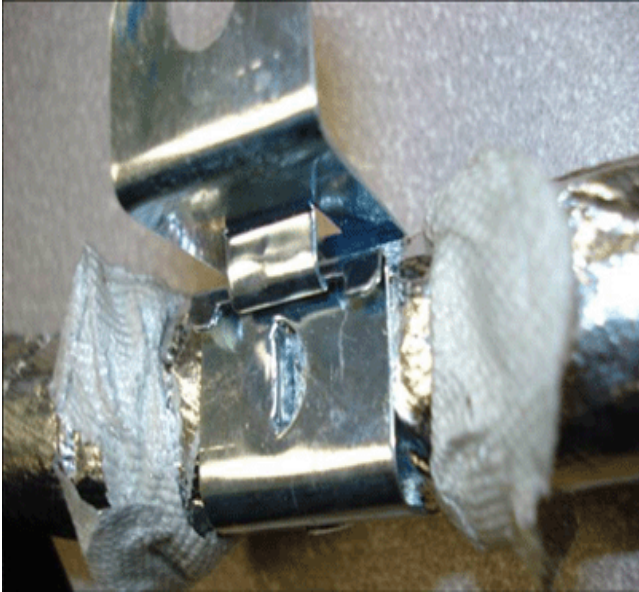
5. Inspect for a pinched/cut wiring harness where it is attached at the transmission by a metal attachment clip as shown. Inspect any of these harness clips that you may observe as needed.

If the wiring is damaged, repair as needed. Refer to Wiring Systems and Power Management > Diagnostic Information and Procedures in SI.

6. Protect the harness by covering the sharp edge with butyl tape or a suitable material. Secure the harness as needed.

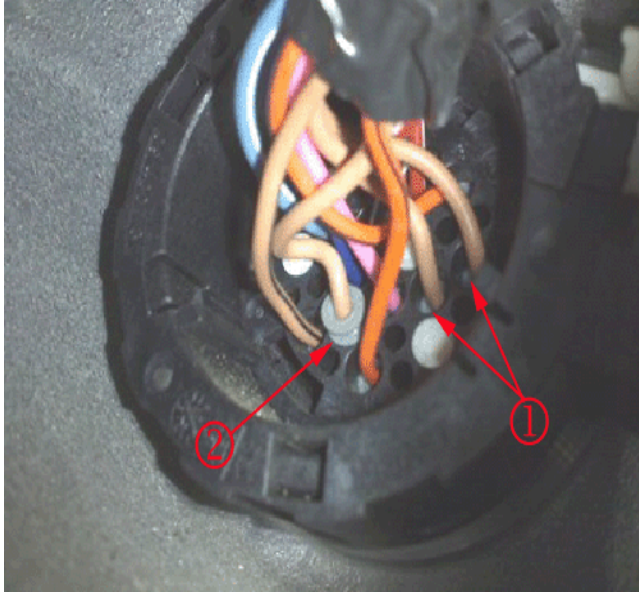
7. **Before** disconnecting the 16-way connector, **inspect** for any backed out terminals (2) as shown. Fully seated terminals (1) are shown for comparison.

- 7.1. If a backed out terminal (2) is found, identify the terminal(s) on the **repair order**.
- 7.2. Look at the connector in order to identify the number of the cavity with the backed out terminal. Refer to Wiring Systems and Power Management > Component Locator > Master Electrical Component List in SI.

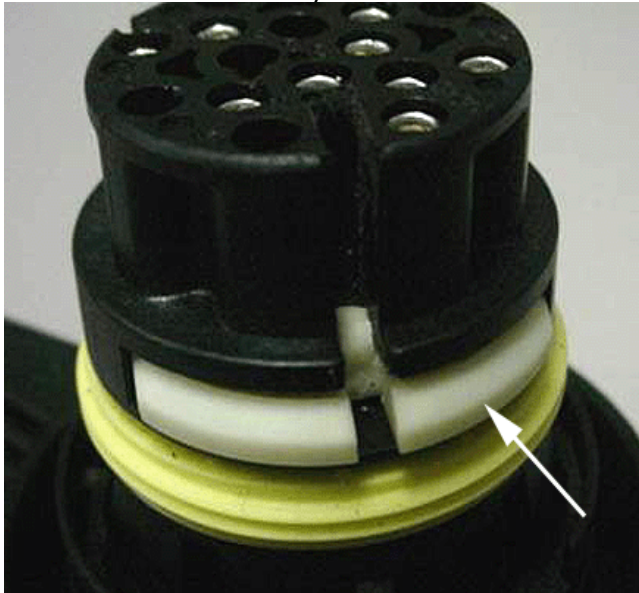
26. Locate the TPA lock in the reassembled transmission connector. Refer to the arrow in the illustration above, which points to a TPA lock. This one is in an unseated position. Using a small flat blade tool, push to seat the TPA until it bottoms out. Verify the TPA is fully seated.

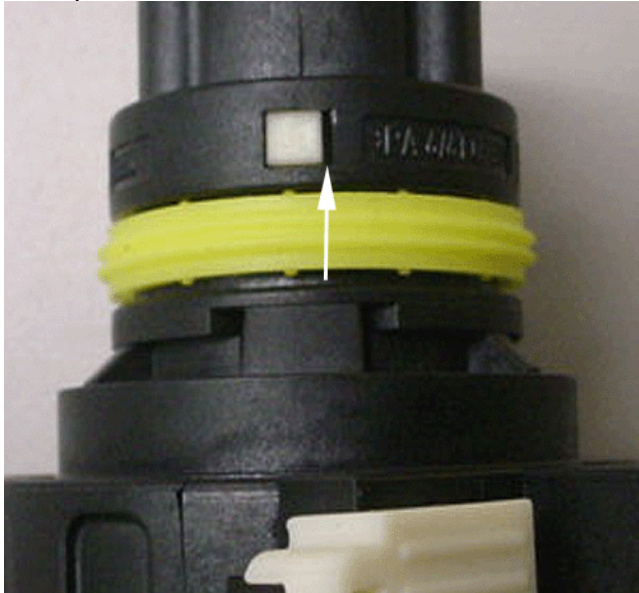
- If the TPA is off-center in the check window as shown, then it is only partially seated. Note the large gap at the arrow. Reseat the TPA lock and ensure that it is fully seated.

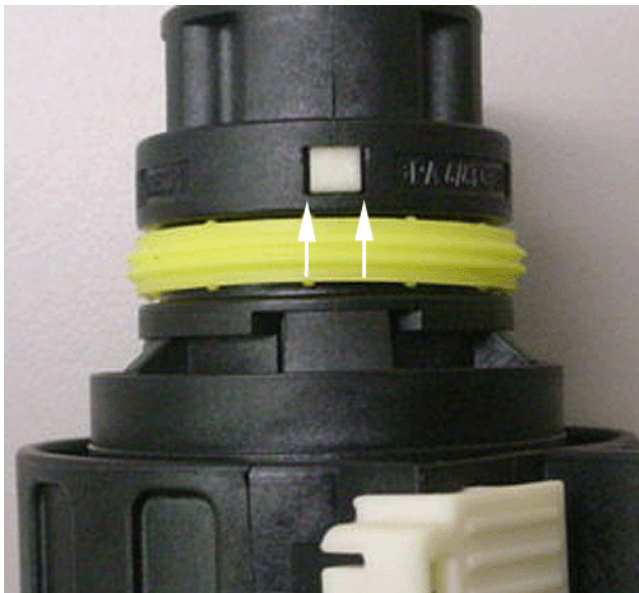
- If the TPA lock is centered in the window as shown, then it is fully seated. The gaps shown by the arrows should be even on both sides.

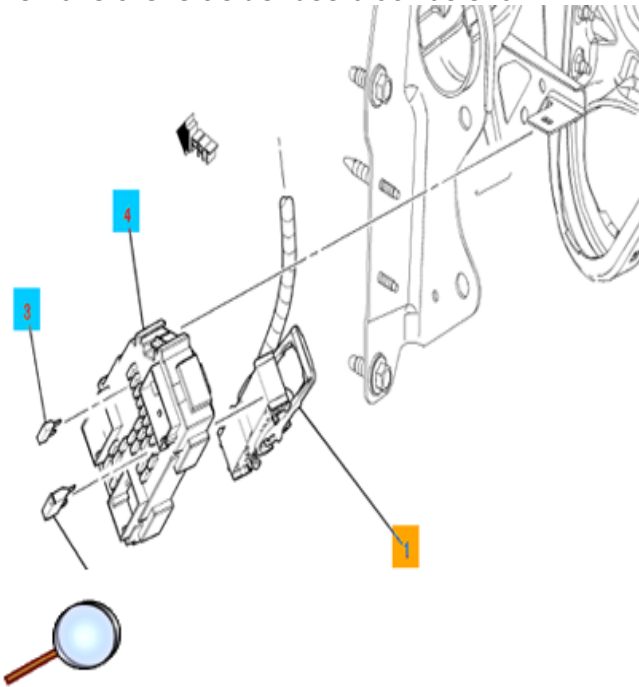
4. Inspect connector X1 (1) on the back of the fuse block for a loose connection as shown. Secure the connector as needed.
5. Install the left side fuse block.
6. Connect the negative battery cable. Refer to Battery Negative Cable Disconnection and Connection in SI.
7. Clear any DTCs that may be present with a scan tool and verify the proper operation of the vehicle.
