2021 Chevy Truck Tahoe 4WD V8-5.3L

DIAGNOSTIC TIP FOR SERVICE LEVELING SYSTEM MESSAGE AND DTC: C1197 SYM92

## #PIT6144D: Diagnostic Tip for Service Leveling System Message And DTC: C1197 SYM92 - (Jan 29, 2025)

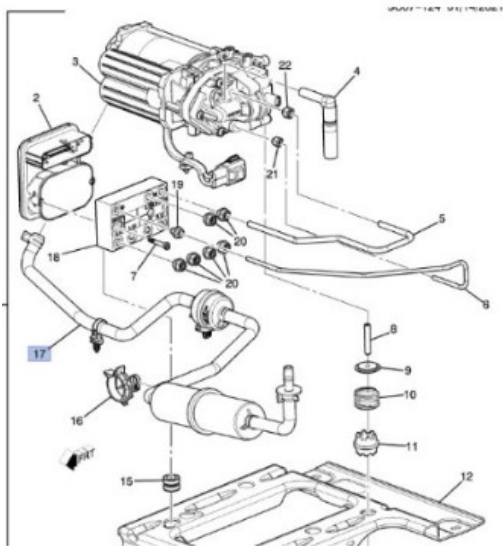
Inspect the air suspension compressor air inlet hose for being pinched or twisted and preventing air from entering the air suspension compressor. The air inlet hose assembly is shown as #17 below. If you find the air inlet hose pinched or twisted, repair as needed.

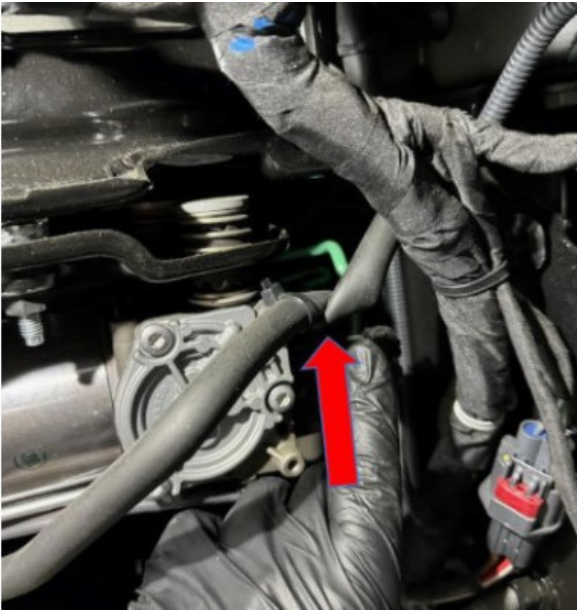
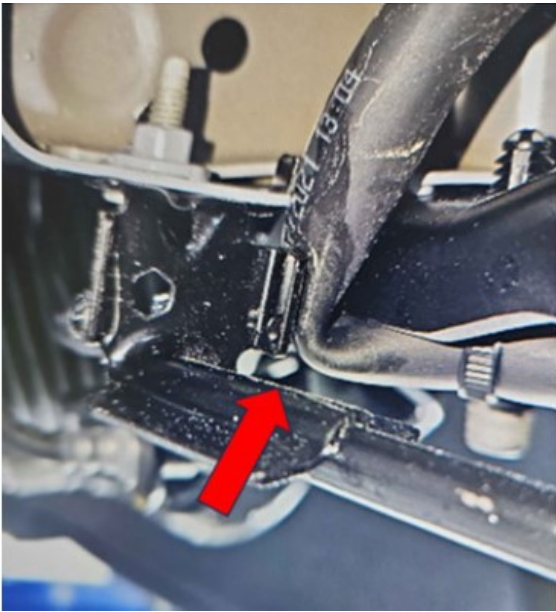
Example of twisted hoses on the 2024 Hummer EV SUV

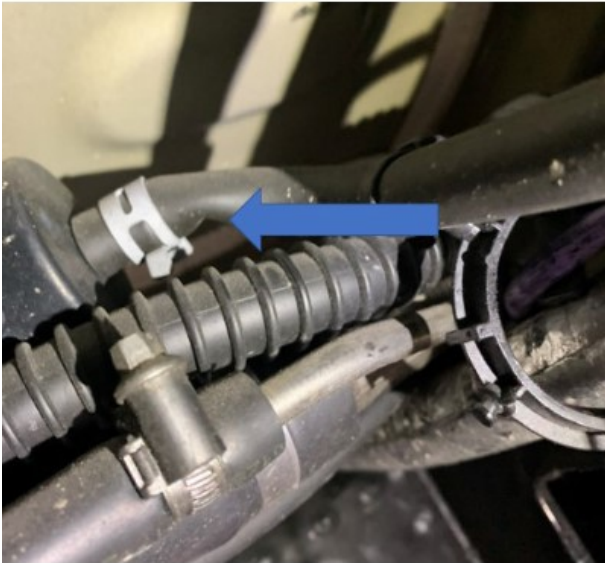
Example of a pinched hose on a 2023 Cadillac Escalade below:

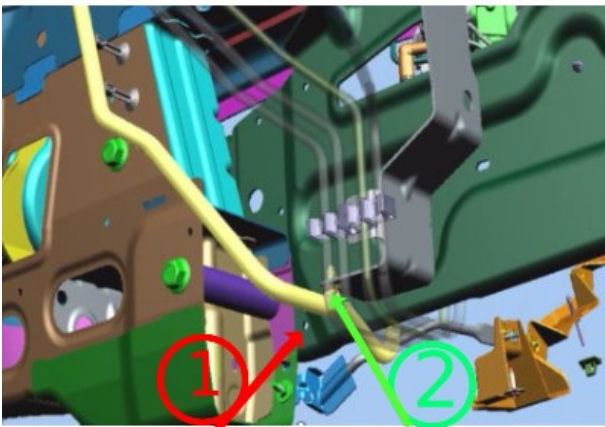
The 2024 Hummer EV Pickup may have an kinked hose due to an air inlet hose fastener that is located in an incorrect mounting hole that restricts the air inlet hose. See Below:

Locate the air suspension line assembly bracket in the right rear of the vehicle and make sure the air inlet line retainer is attached to the bracket as shown above in the locator hole marked by # 2.

If the hose retainer is in location #1, it will restrict the air inlet hose and you will need to remove the retainer clip and install it in location #2.
