## **#08-07-30-021E: Loss of High Speed GMLAN Communications, Intermittent No Crank, IP Gage Fluctuation, Intermittent Door Lock Cycling, Intermittent Chime Operation, Various IP Warning Lamps Illuminated - (Jun 7, 2010)**

**Loss of High Speed GMLAN Communications, Intermittent No Crank, IP Gage Fluctuation, Intermittent Door Lock Cycling, Intermittent Chime Operation, Various IP Warning Lamps Illuminated, Transmission May Not Shift, Communication DTCs U0073, U0100, U0101, U0102, U0109, U0121 or U0140 Set (Repair Backed Out Terminal in Transmission Harness Connector, Repair Open or Shorted GM High Speed LAN Circuits, Open or Shorted Data Link Resistor, Correct Corrosion or Poor Connections in Various Control Module Connectors)**

**2007-2010 Cadillac Escalade Models, XLR  
2009-2010 Cadillac Escalade Hybrid  
2007-2010 Chevrolet Avalanche, Corvette, Silverado, Suburban, Tahoe  
2008-2010 Chevrolet Silverado Hybrid, Tahoe Hybrid  
2007-2010 GMC Sierra, Yukon Models  
2008-2010 GMC Sierra Hybrid, Yukon Hybrid  
2008-2009 HUMMER H2  
Equipped With 6 Speed 6L80 (RPO MYC) or 6L90 (RPO MYD) or Hybrid Two Mode 2ML70 Automatic Transmission  
Please Refer to GMVIS**

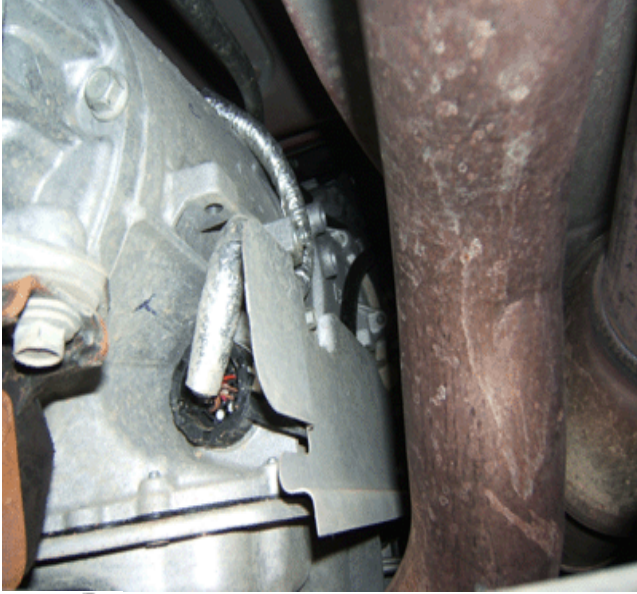
4. Locate the 16-way electrical connector on the right side of the automatic transmission as shown.

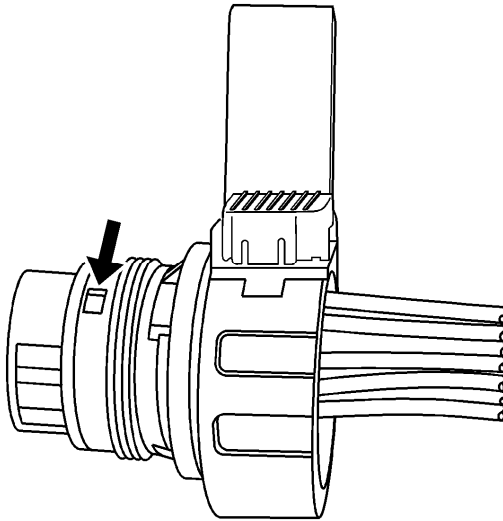
9.1. Locate the terminal position assurance (TPA) as shown.

**Note:** The TPA cannot be removed from the connector while there are terminals present in the connector body.

13. Repair or replace the terminal(s) as necessary using the following procedure:
