Document ID# 800083  
2002 Chevrolet Chevy K Silverado - 4WD

**FIGURE A/C High Pressure Recirculating Switch(c)**

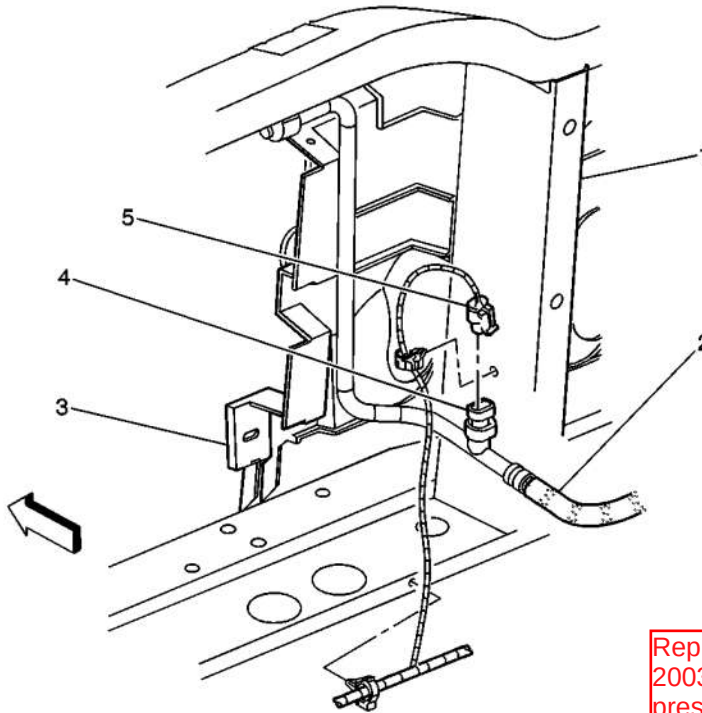
- (1) Radiator Core Support
- (2) A/C Compressor and Condenser Hose
- (3) Headlamp Support
- (4) A/C High Pressure Recirculating Switch
- (5) A/C High Pressure Recirculating Switch Electrical Connector

Replaced switch with a pressure sensor from 2003-2007 Silverado. Use the 1999-2002 pressure port and location and installed wiring along the bottom of radiator shroud along side the headlight wiring harness. 2003-2007 pressure sensor is normally located on the engine near A/C compressor outlet so that sensor can be part of engine harness instead of body harness. Sensor port has schrader valve allowing removal and replacement with system charged. Both switch and sensor use the same style fitting.

Disconnect from A/C High Pressure Recirculate Switch and leave disconnected. Cap to prevent corrosion.
