The clock in our 2007 GMC Yukon XL Denali suddenly displayed no time, just the ‘.’ Attempting the adjust time in the normal manner did nothing but beep with pressing the adjust time keys. I have documented the step I used to get the clock back into operation. I must give credit to a May 2008 posting by “2007TahoeLTZ4x\$” found in “Tahoe Forum.com”. I followed his instructions and the worked. I only took new pictures during my process.

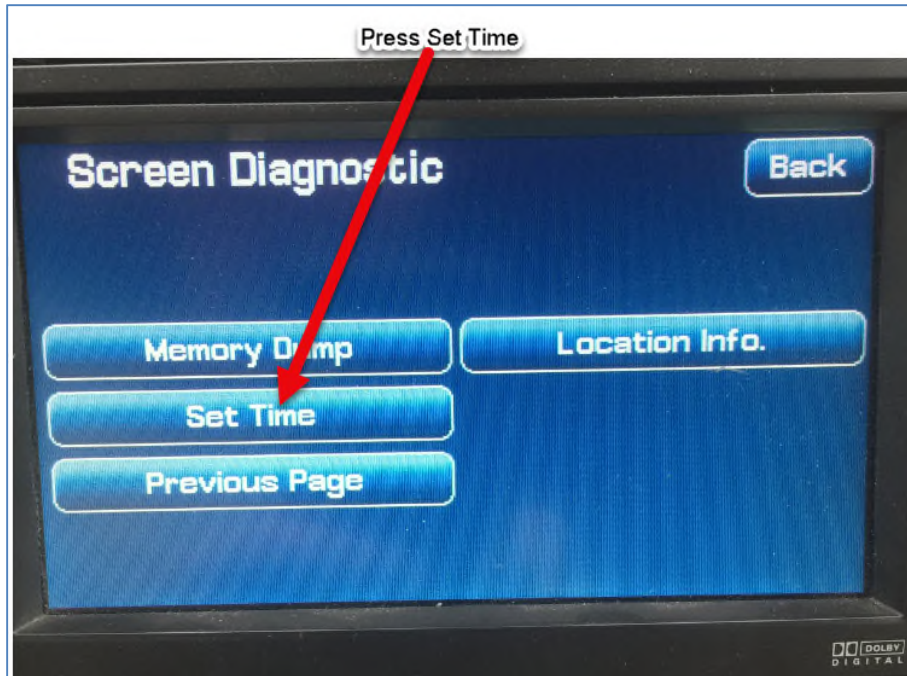
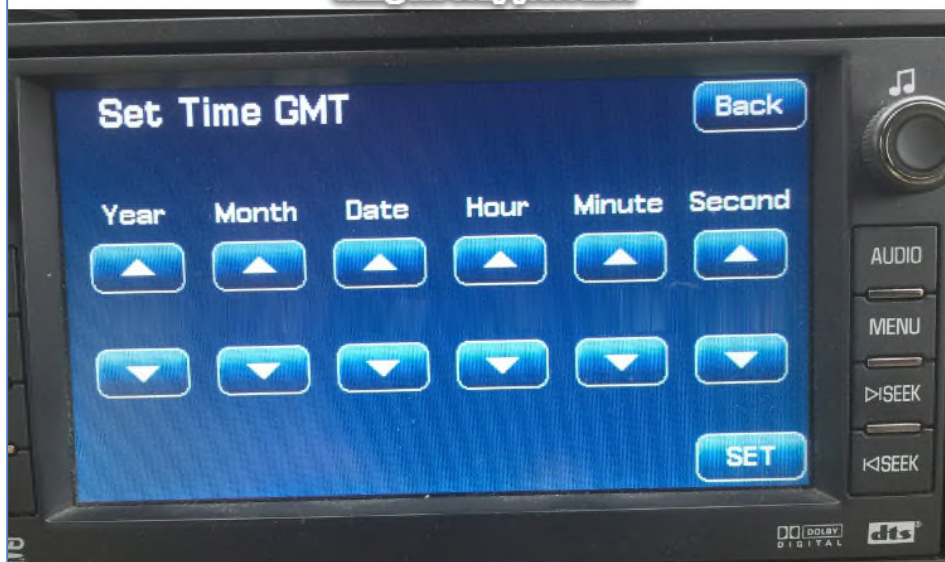
Note that nothing is showing in the columns. Press the buttons to set date and time. Once set to GMT time the clock should display your own timezone after exiting this setup procedure.

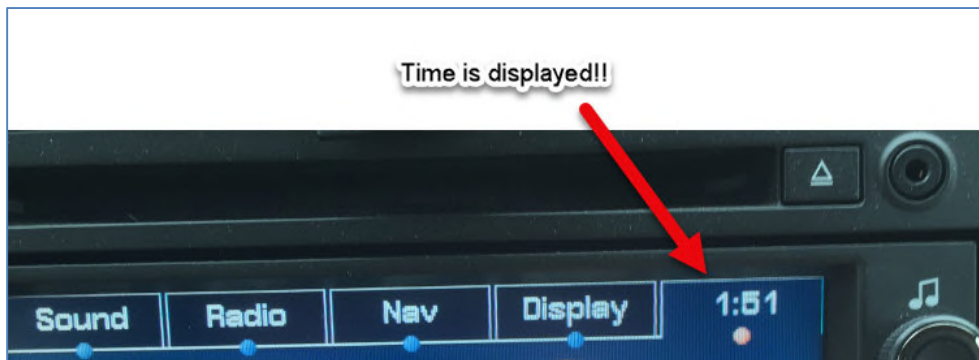
Time is displayed!!
